Gunther Property and the Tolland Agricultural Center

Vernon and Tolland, Connecticut

Eastern Connecticut Environmental Review Team Report

Report #628

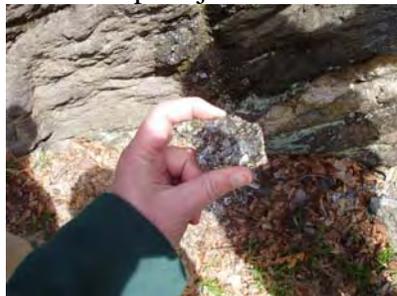
The Littleton Schist is exposed in a road cut in the industrial park just to the east of the Gunther

Property. The Littleton Schist is a silvery gray quartz-muscovite schist that may contain garnets and staurolite crystals.

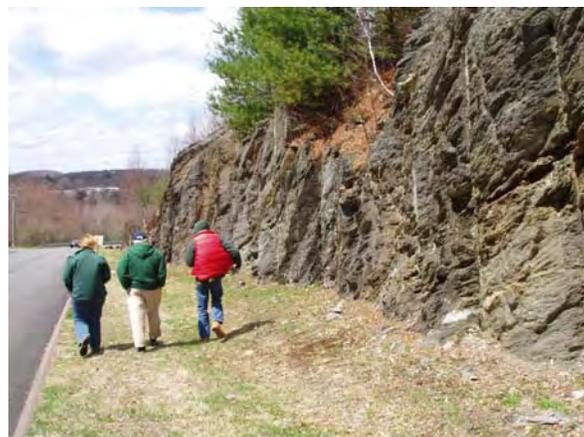
Glastonbury Gneiss underlies all of the Gunther Property and this is covered by sand and gravel left by Ice Age meltwater streams. It is this sand and gravel that was intermittently removed from the area. A deposit of sand and gravel is a valuable resource when the deposits are coarse enough, but some of the sand observed appeared to be fine grained and silty which would have limited economic value. The soils in the lower area were described as “fertile, thick”, “dark brown and loamy” which may have formed as a delta at the edge of a shallow meltwater pond during the last ice age.

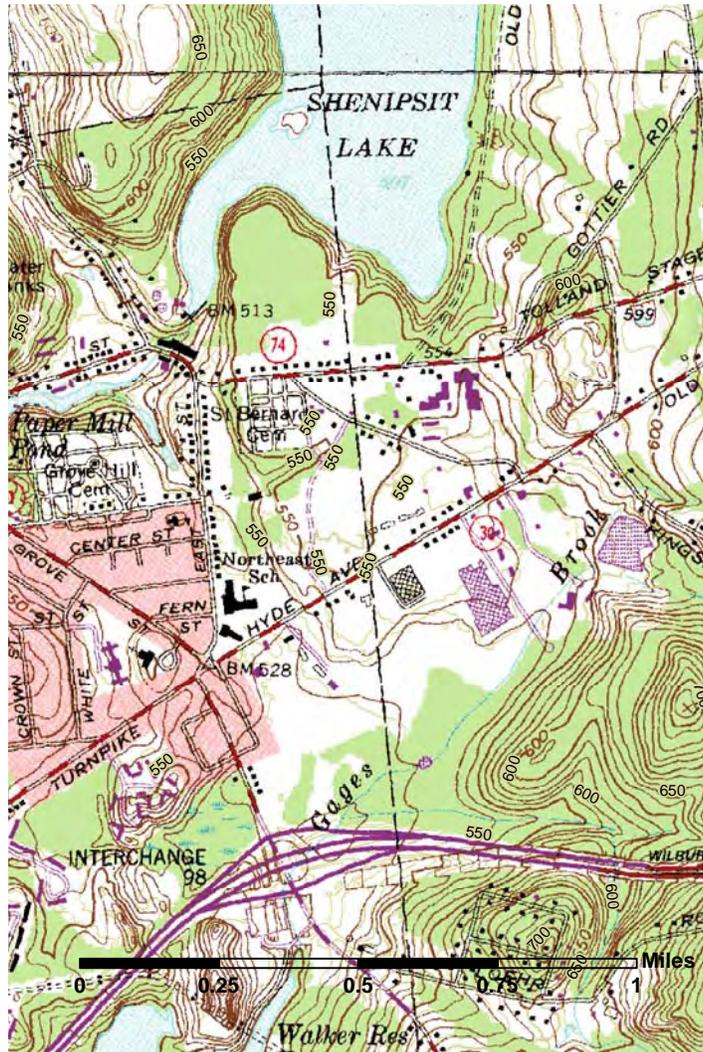
Figure 1. Topographic map a portion of the Rockville Quadrangle showing the location of both the Tolland Agricultural Center and the parcels under consideration for purchase (rectangle shows approximate area, but *not* property lines). Notice that the flat area extends all the way to the southern edge of Shenipset Lake. The topography of hills to the southeast and northwest are bedrock controlled. The rest of the topography results from the shape of sand and gravel deposits formed by meltwater streams at the end of the last Ice Age. Near vertical dashed line is the boundary between the towns of Tolland to the east and Vernon to the west (the extreme northwest corner of the map is in the town of Ellington). Contour interval = 10'.

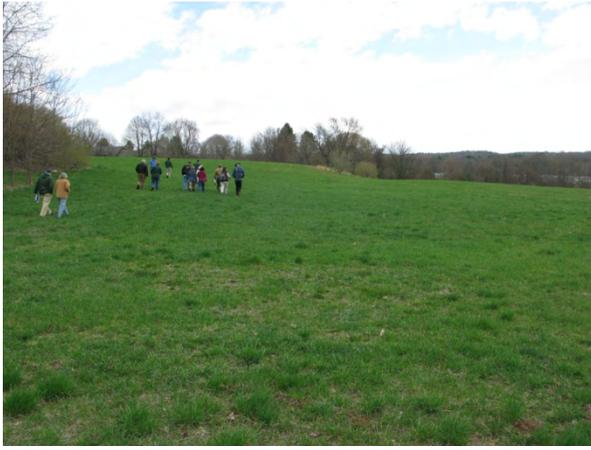
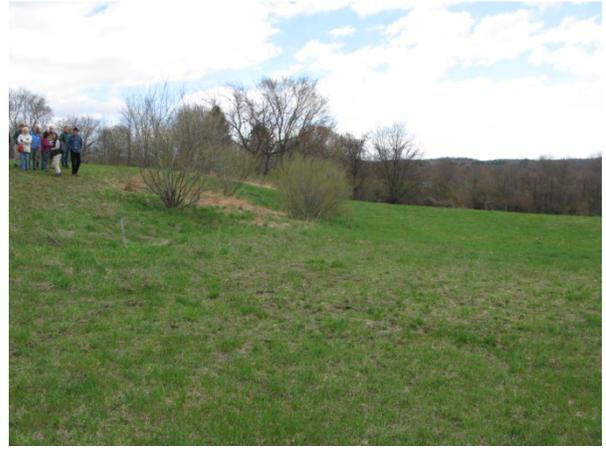
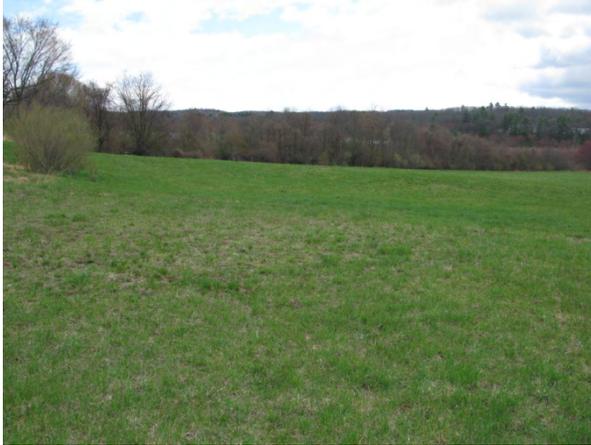
Figure 2. a. Flat upper topographic surface is seen on the left (north) just above Environmental Review Team members; lower surface is to the right. Note the flatness of the surface and then a distinct topographic break. b. Topographic slope between surfaces. ERT members are standing at the slope break. c. Lower gently sloping surface. Note darker green area in middle of image: that was an area where a small amount of gravel was removed according to statements made by Mr. Gunther at the meeting. Bush on left of image is same bush as seen in the middle of Figure 2b.

Topography. The topography of the Gunther parcels is generally rather flat, but not featureless (Figure 1). Two distinct levels are easily seen: a flat upper level (Figure 2a) with an elevation just lower than 550' and a lower level with elevations ranging between 530' and 520' (Figure 2a and c). A gentle slope connects the two levels (Figure 2a and b). This topography is inherited from the environment in which the underlying sand and gravel were formed about 16,500 years ago. The Gunther homestead and barns are built upon part of the upper level. The remainder of the upper level and the lower level are currently farmed for hay. Both levels have been disturbed over the years by past farm activities, including gravel removal in at least one location.

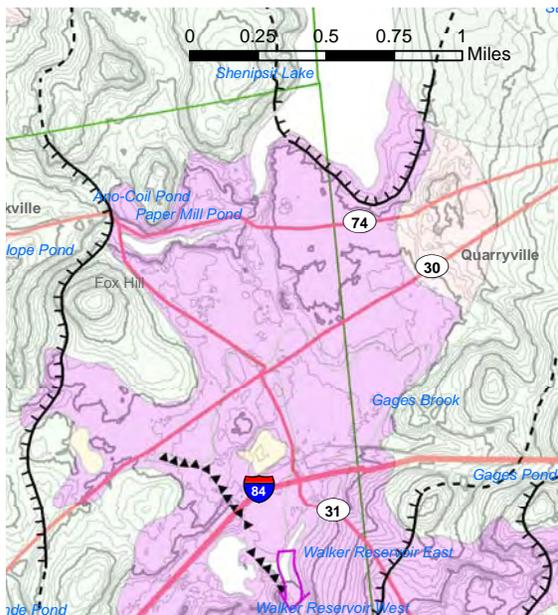
Figure 3. Topographic map on which the extent of several features formed during the melting of the last Ice Age glaciers are mapped. Heavy orange line is I-84; thin orange lines are Rtes 30 and 74. The area colored magenta shows the extent of deposits of sand, gravel and silt in and in and along the margins of a small temporary meltwater lake. Arrow at bottom of map shows spillway that formed when the pond drained. Pale gray and green areas are covered by glacial till. The hachured lines show the position of the ice margin at various times during the melt-back of the glacier. The line of triangles shows the location of an esker southwest of the parcels. Green lines are town boundaries. Shenipsit Lake is the white area on the north-central edge of the map (under scale bar). Note this map shows

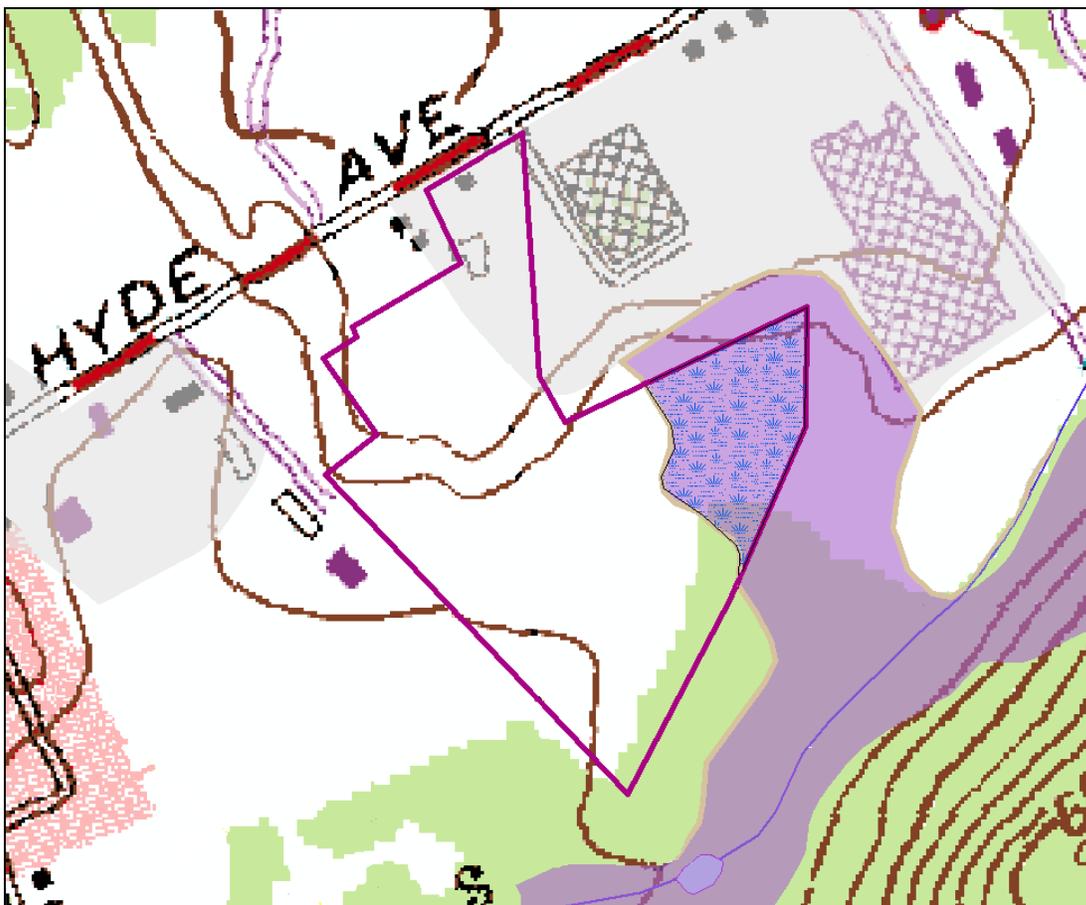
In the graphic above the purple line represents the approximate boundary of the ~22.3 acre Gunther property. The marsh symbols on the eastern-most section of the parcel depict the 3.6 acres of mapped wetland. Gages Brook, seen as a thin blue line, flows from the center of the right hand side of the image to the center of the bottom of the image passing through a small pond on its flowpath. The existing TAC offices and barns are below (south) of the word Hyde in the Hyde Ave. street name.

(Source: USGS 7.5 minute topographic map, Rockville Quadrangle)

Of the 22.65 acres being reviewed, approximately 3.6 acres (~16 per cent) is mapped as wetland soils. These wetlands are contiguous to, and are a part of, the floodplain for Gages Brook which flows east-southeast about 550 feet from the wetland. (See color graphic below)

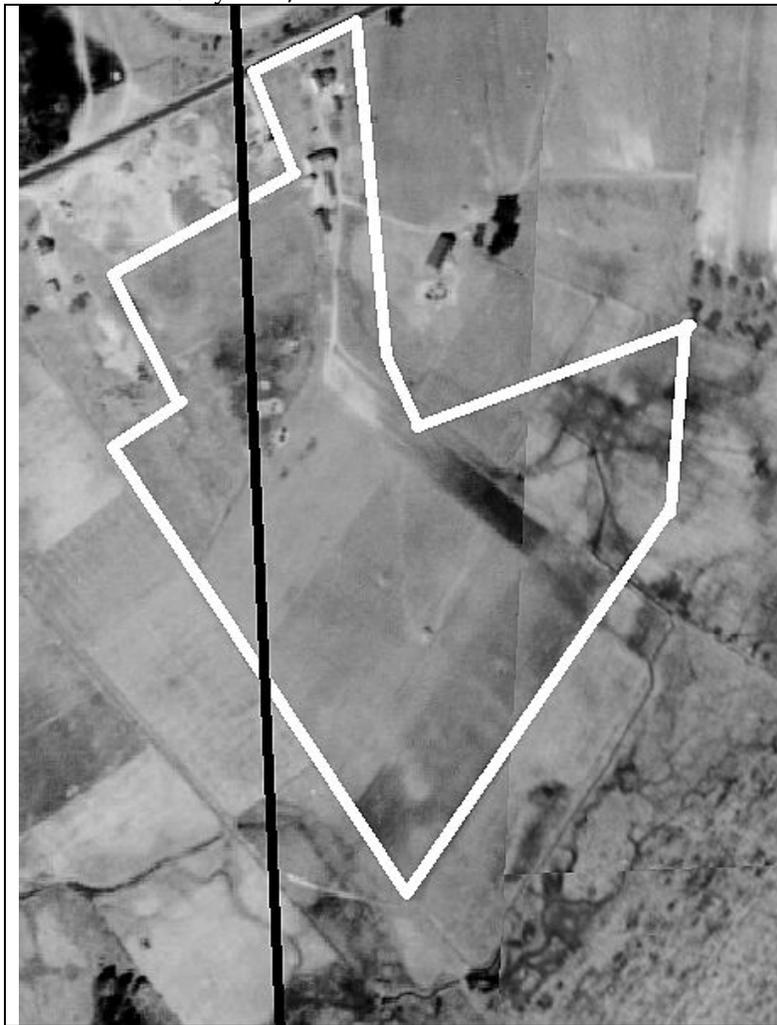
This 1934 Aerial Photograph, with a coarse approximation of current Gunther boundaries in white and the town boundary in black, shows the land-use of the property in April 1934. In the southeast portion of the picture the many arteries (in black and dark shades of gray) of Gages Brook can be seen meandering across the landscape. (Source: Connecticut State Library, Connecticut's Aerial Surveys, 1934 Collection, Photo Number: 02305)

date of the 1934 photograph. It should be clear from this aerial photograph that at that time, hydric/wetland soils were made use of for farming purposes.

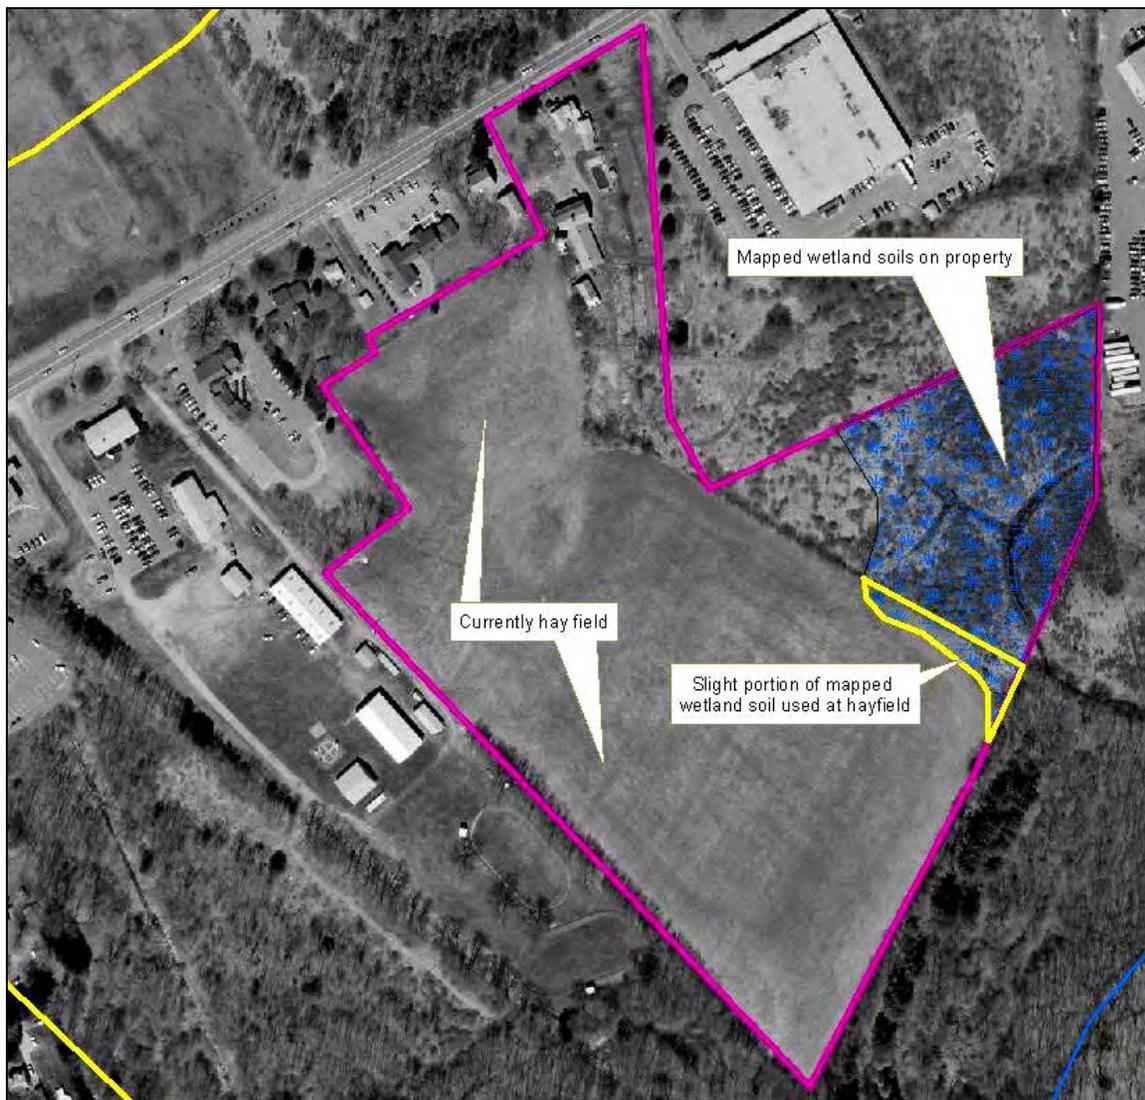
Easily detected on the east side in this photograph are the arc and straight lines of the channelization designed to drain wetland /hydric soils currently mapped on the site. (Source: soils information taken from existing U.S. NRCS soil mapping that makes up the soil layer in the DEPs Geographic Information System(GIS); source date: June, 2011.)

Comparing the above photograph with the one below it is clear that the hydric areas, especially floodplain wetland, have been historically altered. This photo, taken in spring 2004, shows both the location of the mapped wetland soils and the small portion of mapped wetland used for hayfield still today.

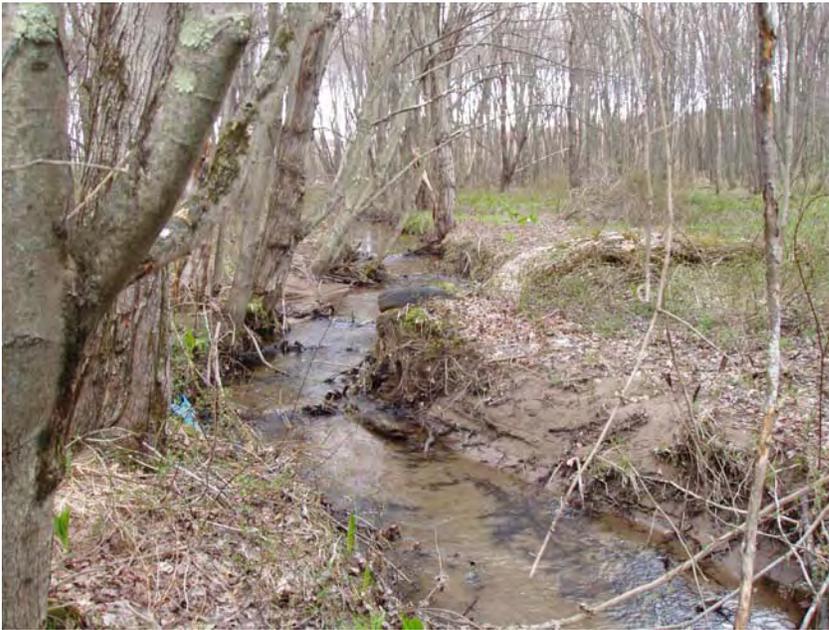
The Gages Brook riparian zone shows evidence of past disturbances that have created a somewhat partially open riparian canopy decreasing its ability to shade solar radiation and prevent increases in stream water temperature. In addition, there is extensive growth of the invasive plant multiflora rose that has impacted the composition and

diversity of riparian zone vegetation.

Gages Brook is a small first-order headwater stream that empties into Walker Reservoir located within the Tankerhoosen River Watershed. Gages Brook is incised as it flows through Tolland Agricultural Center (TAC) property. Incised channels are deep-well defined with very narrow widths often caused by rapid down-cutting into substrates. This condition has resulted in an unstable channel that continues to downcut, erode its streambanks and lose contact with its floodplain. Upper sections of the brook have been channelized (straightened) due to man-made alterations associated with past agriculture practices and development of the Tolland Industrial Park. Increases in impervious surfaces in the watershed have probably caused or exacerbated stream incision and streambank erosion.

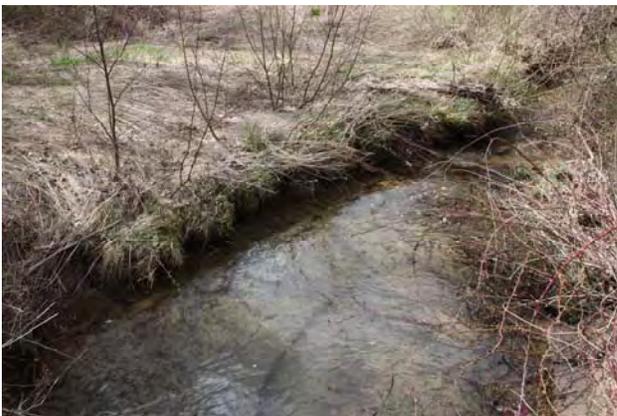
Streambed substrates are comprised of small gravels intermixed with fine to coarse sands. Sands appear to mostly emanate from runoff due to winter roadway deicing activities and some natural materials that have eroded from unstable sections of the streambank. Stream mesohabitats are mainly in the form of alternating riffle, run and small pool sequences. Pools are somewhat shallow and lack adequate instream cover and depth.

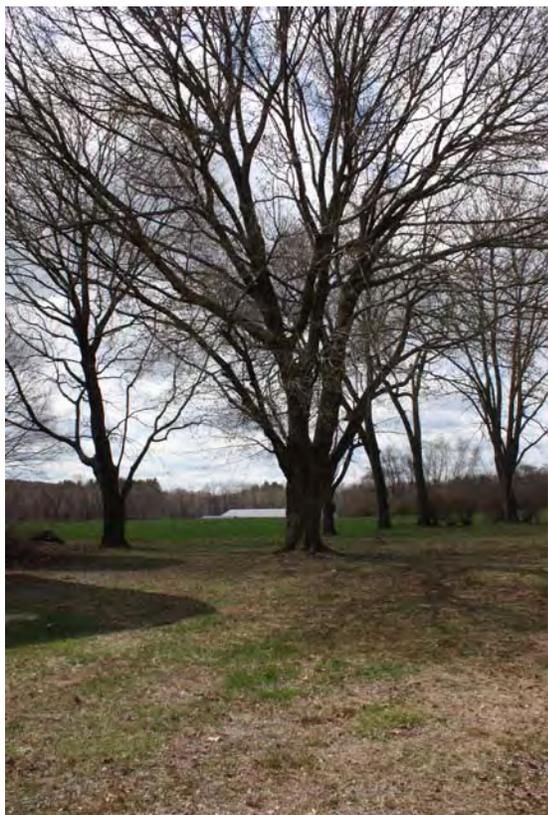
Recommendations and Comments on 7 Management Zones:

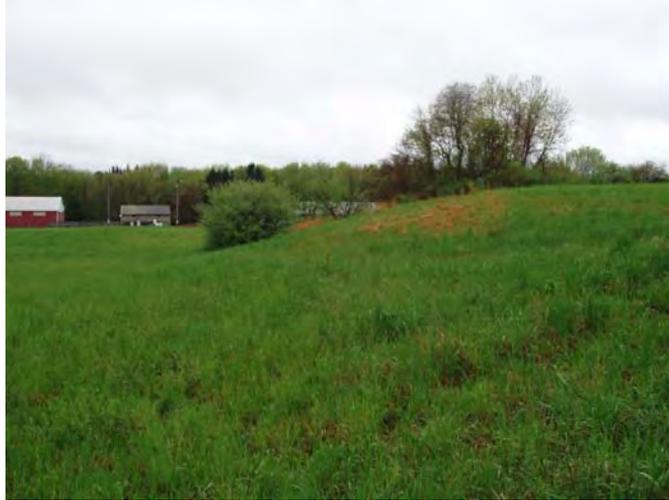
Zone 3: Triangle-shaped former livestock holding pen (easternmost portion of Gunther property)

- Although this area has many species of invasive plants present, it also provides shrubby wildlife habitat (an increasingly uncommon type of habitat in Connecticut)

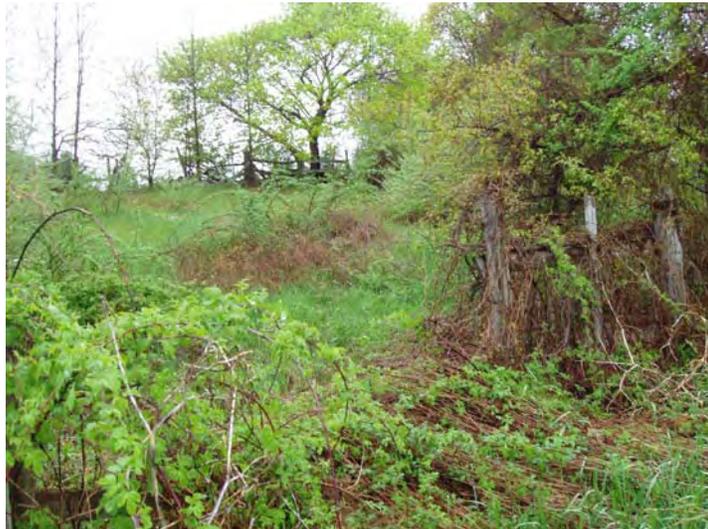
- The Multiflora Rose is well-developed making passage through the area hard for people.
 - Multiflora Rose cover is better than no shrubby cover at all.

- At some point it would be worth mowing the area (with a Forestry mower) to encourage the shrubs to re-sprout with dense new growth – promotes flowering and to prevent young trees from growing up to dominate the site.

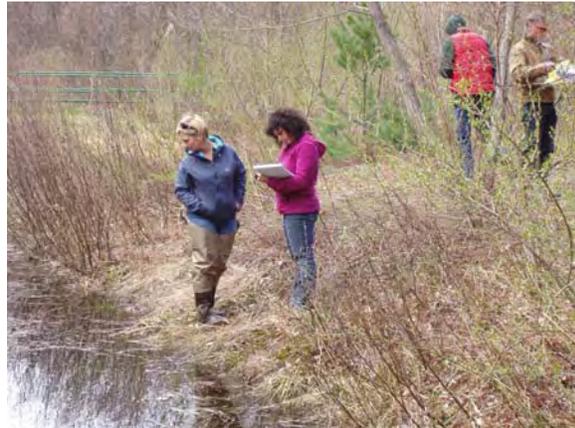
Zone 6: Woods beyond the pond area

- This area is comparatively free of invasive plants.
- Volunteers might be asked to do:
 - Monitoring for, and removal of, Garlic Mustard
 - Removal of scattered invasive shrubs (Japanese Barberry, Multiflora Rose) with a weed wrench
- Continuation of the native plant labeling project is recommended
